Performance Issues of Pavement with Cementitiously Stabilized Layers

Abstract: Our country has built highways for the semi-rigid base asphalt pavement structure, the structure bearing capacity is strong, rut depth is small, good water stability, and has become the main structural type of high grade highway in China. But the practice has proved that there are some inevitable semi-rigid base asphalt pavement of technical problems, in a number of highways open to traffic soon after the pavement early damage phenomenon more serious, such as rutting, and vertical and horizontal cracks, cracks and potholes, local loose aging, seriously affected the normal traffic, but also violates the highway within the use fixed number of year is not for the purpose of the large maintenance. This paper analysis the properties of cementitiously stabilized materials linked to pavement performance, summing up the experiences of domestic and foreign research and related pavement distresses and the fatigue of CSL and related pavement distresses, stiffness of CSL and related pavement performance and erudibility, to do researches for the development of the improvement of the pavement.

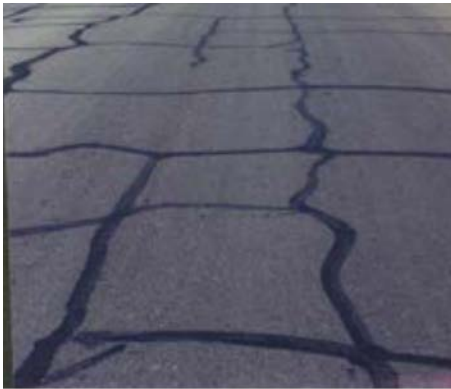
Block cracking often is reported in the HMA surface when the pavement has a stabilized base. Block cracking is caused by shrinkage of the underlying stabilized base and often occurs when the HMA layer is thin, as for local roads (Figure 1). Highways in many parts of the world that use stiff bases and thin HMA layers also have encountered this problem (Yue 2004, Zube 1969). The shrinkage, caused by a loss of moisture and temperature variation, typically initiates shortly after construction and continues thereafter. According to Zube (1969), high unconfined compressive strength (UCS) causes block cracking which is likely due to the high shrinkage of CSL with high cement content and high strength. In short,

Figure 1. Block Cracking in HMA with Stabilized Base (Scullion 2002)

block cracking can be attributed to the shrinkage of CSL [2].

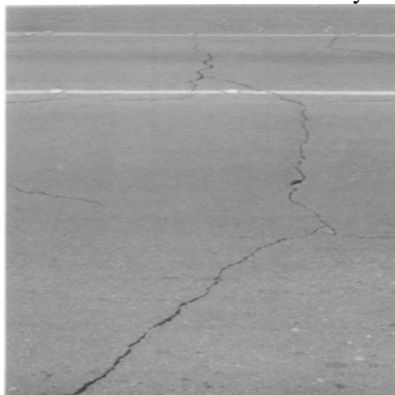
Transverse cracking in the surface layer that results from shrinkage of the stabilized base, as shown in Figure 2, starts from the bottom of the surface layer and propagates through the surface layer. The cracking is due to the bond between the surface layer and stabilized base and granular base, but at a much later stage (Ramsey 1959). The shrinkage cracking of the subbase causes stress concentrations at the locations of the cracks and eventually affects the stress distribution in the surface layer.

Figure 2. Transverse Cracking due to Shrinkage Cracking of CSL (Freeman and Little 2002)

Atkinson (1990) reports that shrinkage cracking in CSL causes transverse cracking in HMA and is prominent in thin HMA pavement. Chen (2007) reports that lack of mellowing for lime slurry stabilized base layers causes shrinkage cracking and then transverse cracking in the HMA surface [4]. Little et al. (1995) found that a high modulus value causes wide shrinkage cracks and low load transfers across the crack.
