# Properties of Cementitiously Stabilized Materials Linked to Pavement Performance

Keywords: CSL; Shrinkage of CSL and related pavement distresses; Fatigue of CSL and related pavement distresses

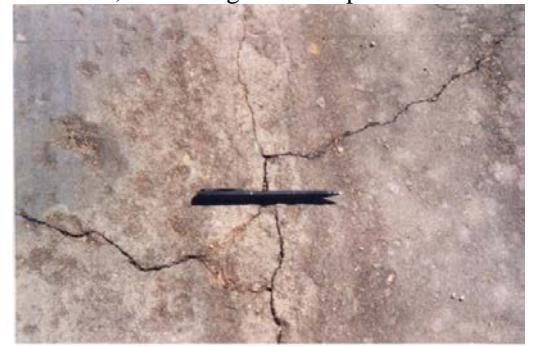
Shrinkage cracking of CSL as base layers, as shown in Figure 1, can cause the cracking of the surface layer due to the bond between the surface layer and the CSL. Shrinkage of CSL includes autogenous shrinkage due to hydration, drying shrinkage due to loss of moisture and thermal shrinkage due to low temperature contraction

Figure 1. Shrinkage Cracking of CSL (George 2001)

(ACI 2008). Shrinkage of CSL, when restrained (e.g., bonding from underlying layer), causes the development of tensile stress in the CSL. When the tensile stress exceeds the tensile strength of the stabilized materials, shrinkage cracking occurs (George 1990)[1]. Shrinkage cracking could occur within a few days or over a couple of years, depending on the curing, shrinkage strain, and other factors. Shrinkage of CSL is affected by many factors, such as moisture, additive content, raw material characteristics, and curing after compaction.

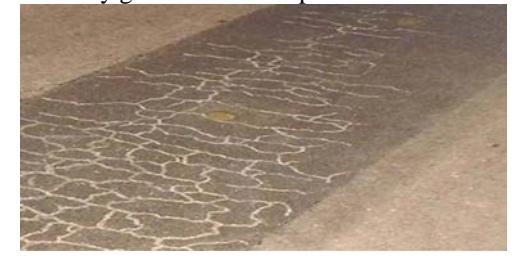
Bottom-up tensile-fatigue of CSL, as shown in Figure 2, occurs as a result of tensile strain at the bottom of the CSL due to repeated traffic loads. Otte (1978) studied the fatigue cracking of CSL and reported that when the tensile stress exceeds 35% of the strength or a tensile strain

Figure 2. Fatigue Cracking in CSL (Yeo et al. 2002)

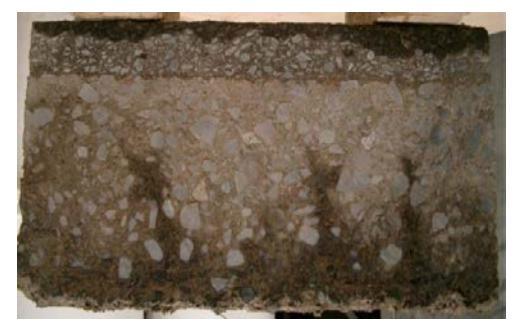
level of more than 25% of the break strain in a flexural beam test, microcracking starts and the stress-strain relationship becomes nonlinear. Microcracks initiate at the bottom of the CSL and propagate upwards, as shown in Figure 3. According to Theyse (1996), bottom tension fatigue consists of three phases. De Beer (1990) reports that bottom-up cracking typically occurs in relatively thin CSL in which tensile strain could cause fatigue damage[4]. The fatigue life in the laboratory is multiplied by a shift factor to account for traffic that occurs between the time of crack initiation and visible cracks. The bottom-up fatigue consists of three phases: (1) a precracking phase (including shrinkage cracking) prior to fatigue initiation, (2) fatigue initiation and propagation, and (3) a post-cracking phase. The duration of the precracking phase consumes about 20% of the life of the CSL. During fatigue propagation, the modulus of the CSL decreases due to fatigue damage. Permeability of the CSL increases as the number of loads increases due to cracks. The rate of degradation of the effective modulus is 52 ksi per 1 million loads for the wet state. In Phase 3, the CSL degrade into small pieces. The size of the degraded CSL depends on the strength of the CSM. After Phase 3, the disintegrated pieces could intrude into the underlying subgrade. During the post-cracking phase, the effective modulus value of the CSL is equivalent to that of the granular materials in terms of CSL thickness. When CSL is dry, the size of the equivalent granular materials is about 1.5 times of the CSL thickness and, after it is wet, the size is 0.3 times that of the CSL thickness. During the post-cracking phase, compressive strength and erodibility govern the rut depth.

Figure 3. Fatigue Cracking in CSL Trenching (Moisture in Cracks) (Yeo 2008)
